# The Trench

To prevent the escape of water by seeping under the embankment, a cut-off trench was dug down to the impermeable strata for the whole length of the embankment. This was then filled with concrete to form an impermeable barrier.

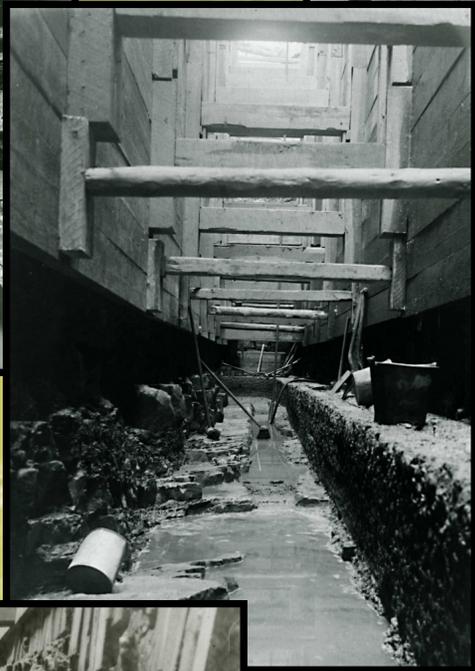
Trench bottom

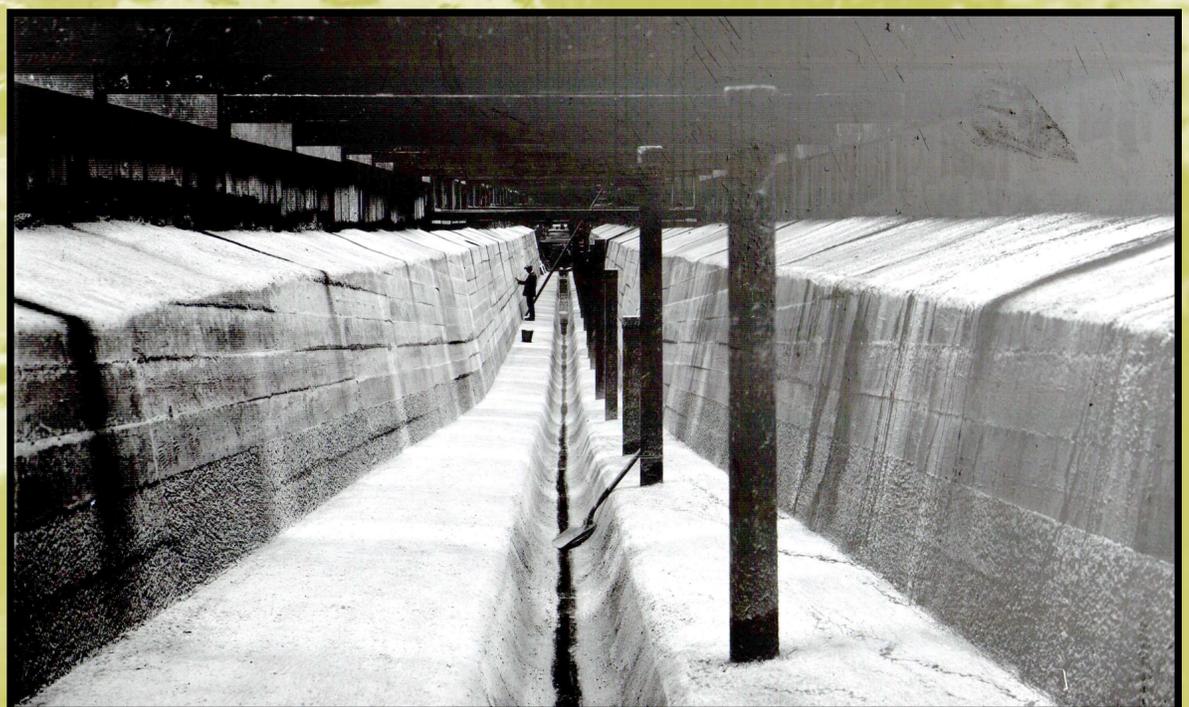
Concreting within the trench 1914
