Forming and finishing the Embankments

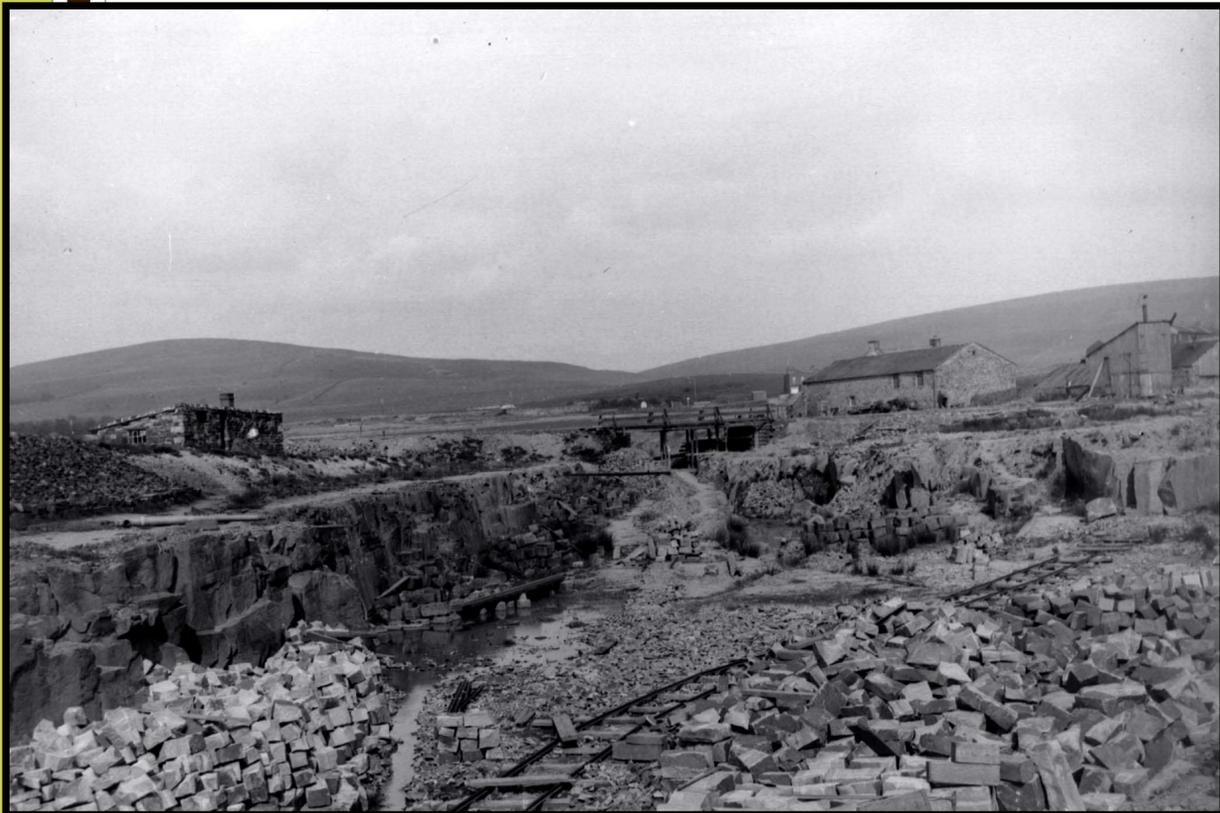
Blocks stacked in the quarry in the bottom of the reservoir looking East
16th June 1909.

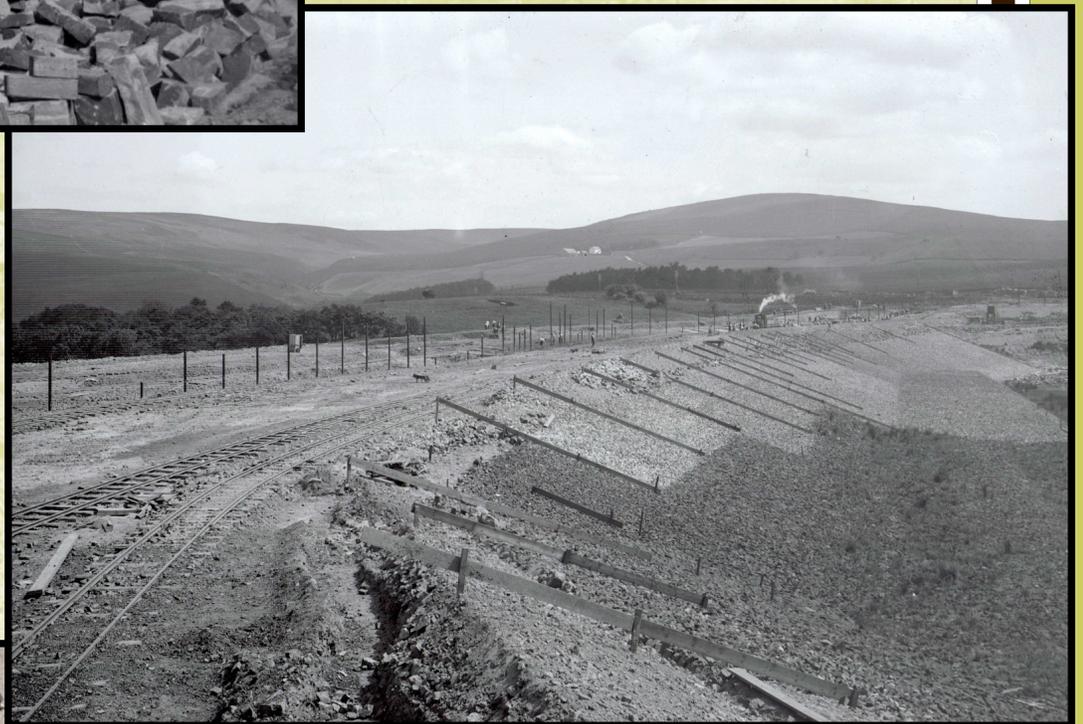
Grizedale Lea,
North embankment
looking North East 6th June 1914

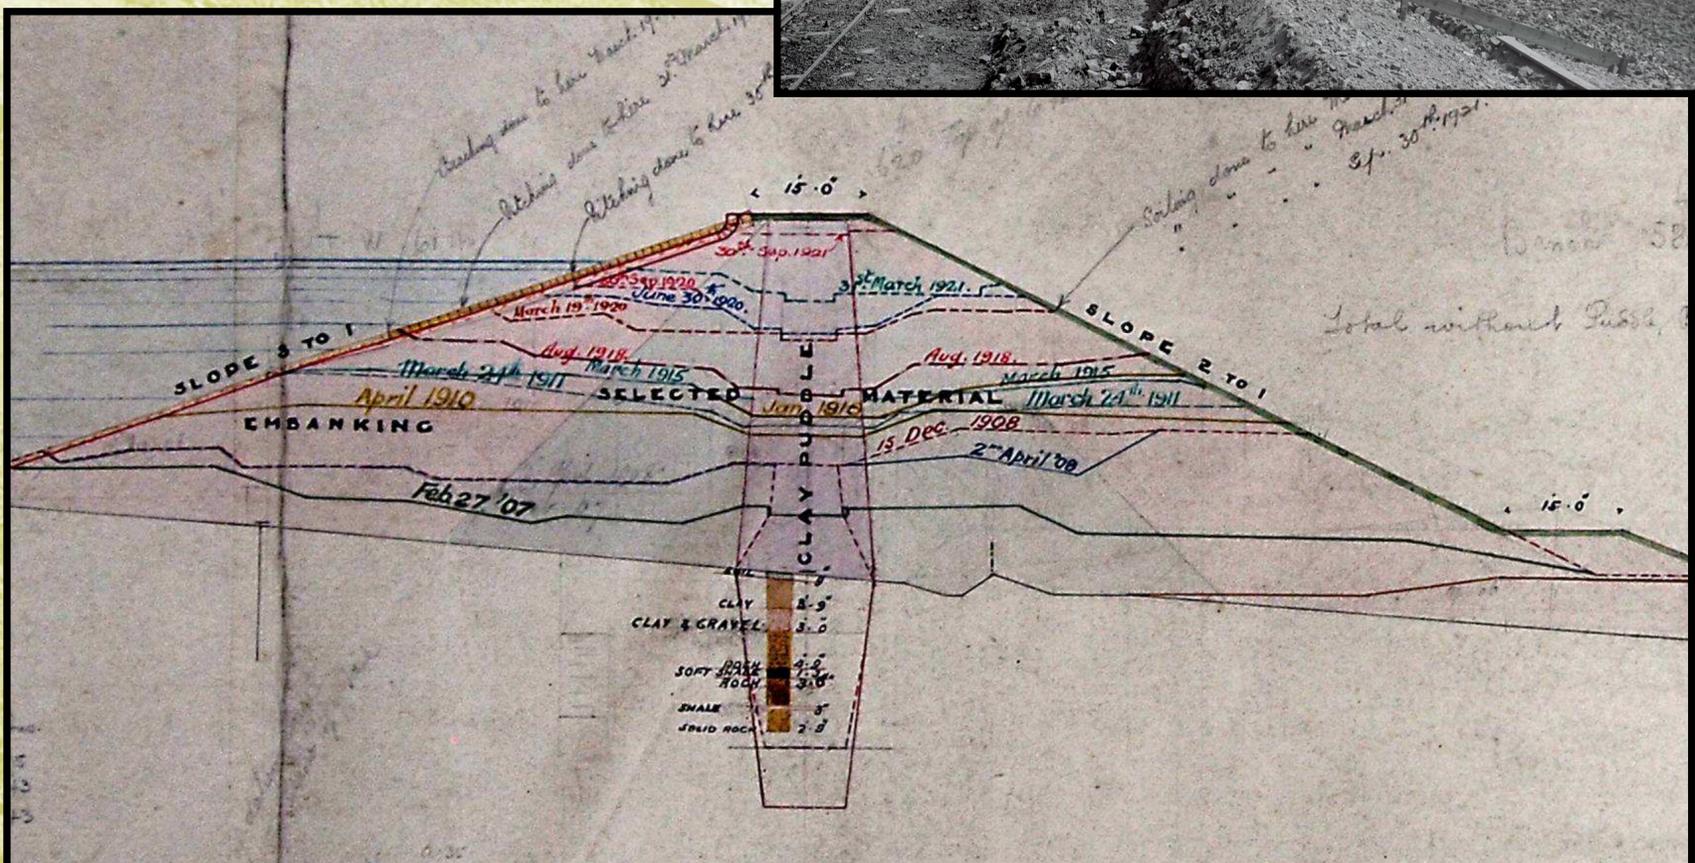
Central in the embankment is the puddle clay core. Formed of soft clay, this was 'puddled' into place in thin layers by the workmen wearing high heeled boots to ensure a continuous barrier was formed.

Drawing showing section of embankment - between Feb 27th 1907 and 30th Sept 1921.
